## **Technical Bulletin**

**N°: TECB-**08-12-15\_RO

Diamond model considered: FSM-16E/N

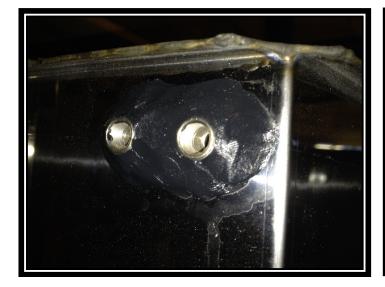
Problem: Leakage risk

Action (what-when): Since October 2015 we have add a silicon gasket around the capillary clamp press

Technical solution suggested : Add a silicon gasket

New replacing spare parts codes: added of high temperature silicone
