Operation Guide – GB33

Trouble Shooting Guide – GB33

Repair Guide

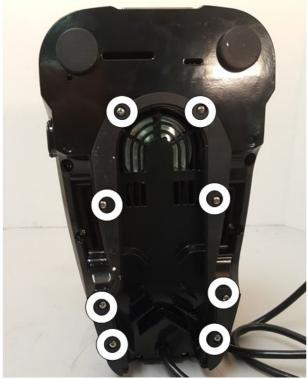
Fig. 21: Remove these screws in the base to get to the belt pulley area.

- Symptom: The Power Light comes on (unit gets power) but the unit will not start.
- Cause(s): Probable causes are the touchpad could be bad or the white motor lead is possibly broken at the PCB board. (see Fig. 31) Refer to figs. 1-7, 15-16, 21-23 and 32-34 to replace the touchpad. Refer to Figs, 1-9, 15-16, 21-23 and 27-30 to replace the motor.

- Symptom The output assembly will not turn when the motor is energized and there is a burning smell.
- Cause (s) The blender spindle is locked up and/or the belt is damaged. Refer to Figs. 4-6, 21-26. the installation is the reverse of disassembly.

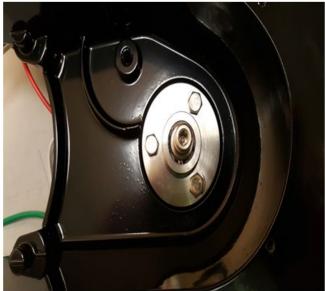
Fig.25:
Use a 10mm socket or wrench to remove the output assembly.
