Trouble Shooting Guide

Repair Guide

Hamilton Beach	Revision	Added ERROR	Added ERROR message info for troubleshooting								
4421 Waterfront Drive	Description:										
Glen Allen, VA 23060	Request #:	DOC13319	Page:	2 of 9	Document #:	520011601	Rev:	В

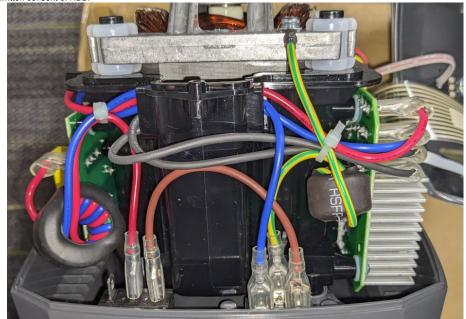
Figure 2. Interior View of Power Cord Socket and Non-illuminated Circuit Breaker Switch

Circuit Breaker and Cord Socket Wiring Details (See Figure 2)

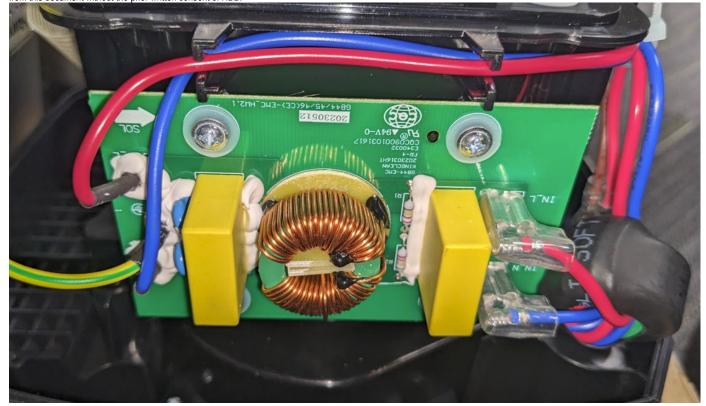
Figure 3. RFI FILTER

RFI Filter Wiring Details (See Figure 3.)

- Disconnect wires from RFI board, mark if necessary or refer to wiring detail for proper placement.
- Remove the four Phillips screws and gently pull the RFI board

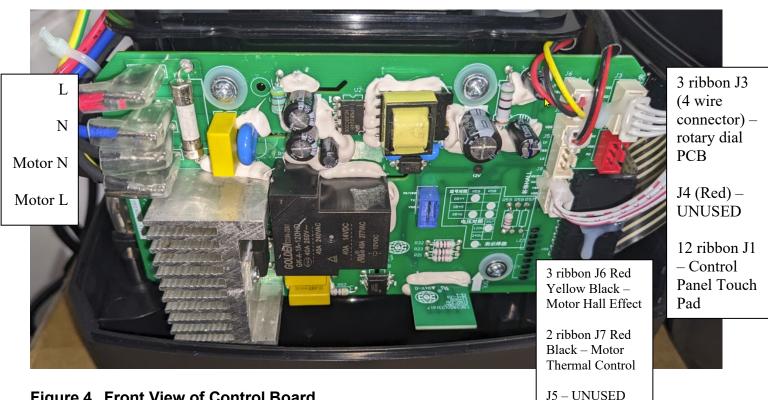
Figure 4. Front View of Control Board.

Control Board Wiring Details (Figure 4) & Control Panel Wiring Details (Figure 5)

- Red wire (on left) routes to the left side of EMC Board.
- Blue wire (on left) routes to the left side of EMC Board.
- Upper Black wire (on left) routes to the Motor non-thermal control device side.
- Lower Black wire (on left) routes to the Motor thermal control device side.
- Red/Black/Yellow ribbon J6 3 wires route to the Motor Hall Effect sensor.
- Red/Black ribbon J7 2 wires route to the Motor NTC Thermal control device.
- J5 Connector = unused
- White ribbon J8 4 wires (below J5) routes to the Jar Sensor on the underside of the Upper Housing.
- White ribbon J3 4 wires in 4 wire connector (upper right corner) routes to the Rotary Timer Dial on control panel.
- Red connector J4 = unused
- Large Black J1 is the receptacle for the 12 wire ribbon from the Control Panel Touch Pad
